## Fracture surgery | Forth Road bridge repairs

7 November, 2016 By [Katherine Smale](#)

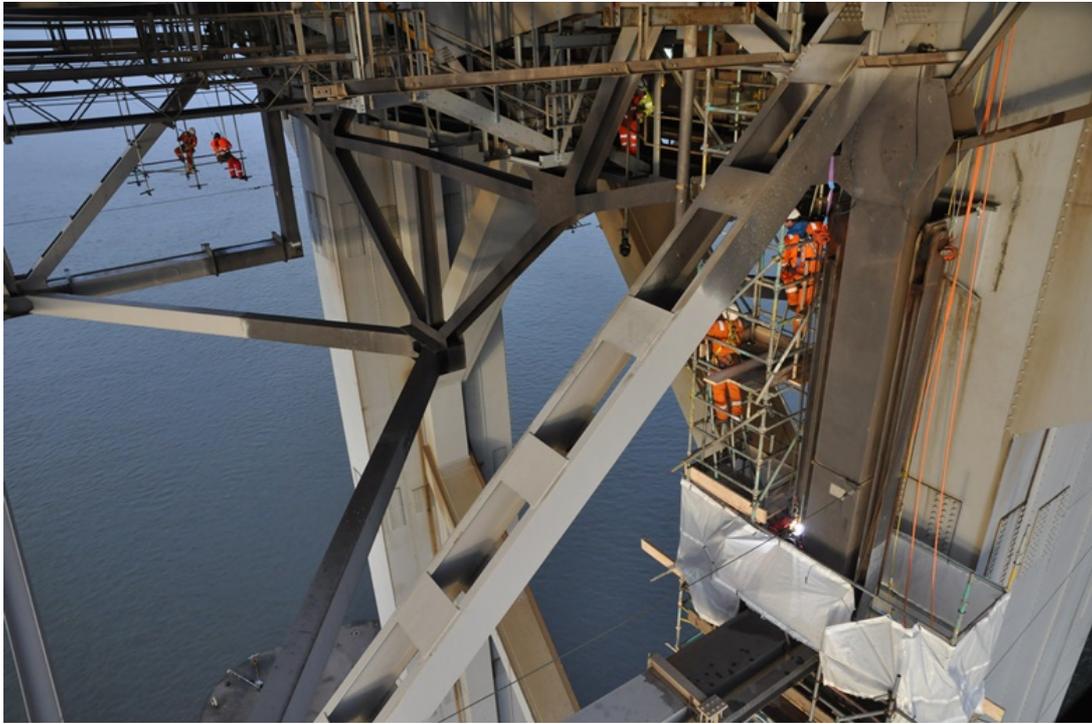
Forthbridge(2) scaffolding and inspection

Worker inspect the truss end link from suspended scaffolding

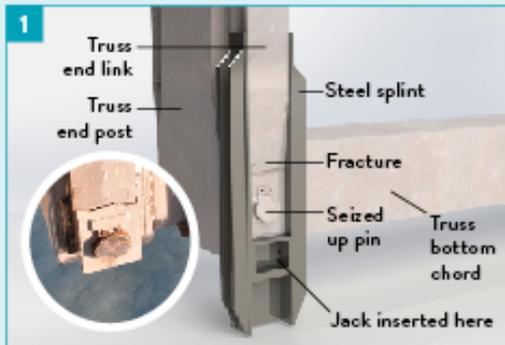
### 1 | PHASE ONE

A splint is created around the link to close the crack and restore its structural capacity.

To provide a temporary solution, a set of specially designed steel splints was welded to the sides and the bottom of the truss end link, forming a U shape around it. A gap was left between the bottom plate of the splint and the underside of the link member, allowing a jack to be inserted to lift the lower section of the truss end link.

The jack then closed the 20mm to 25mm gap created by the fractured parts, effectively restoring the end link’s original load bearing capacity.

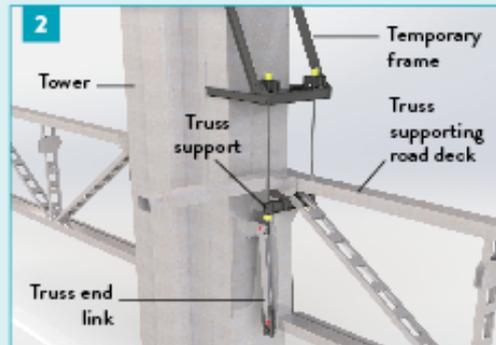
### 2 | PHASE TWO

A 9.5m high frame is installed above the deck to support the truss, removing the traffic load from the failed member and allowing the bridge to reopen to traffic.

To do this, the team bolted a 4.4m tall steel frame to the main tower above the deck and from this, the truss is now supported by two parallel strand jacks. These thread through the deck to the underside of the top chord of the truss.

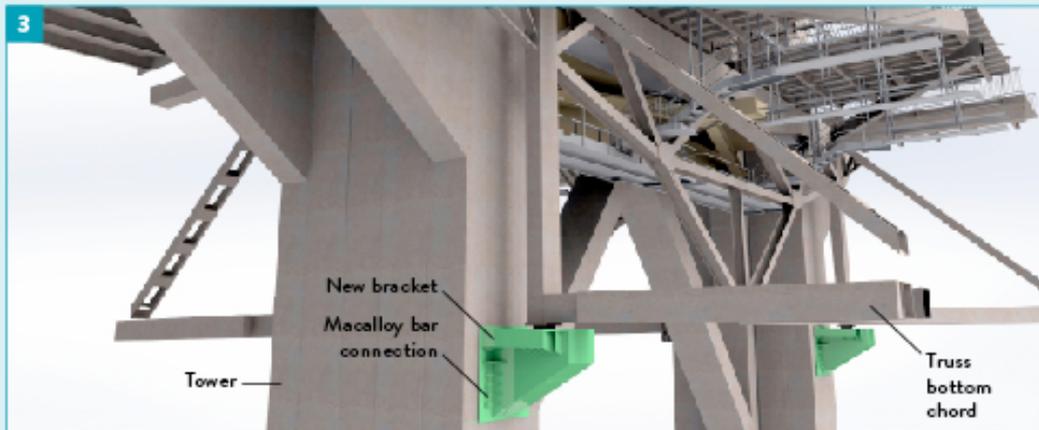
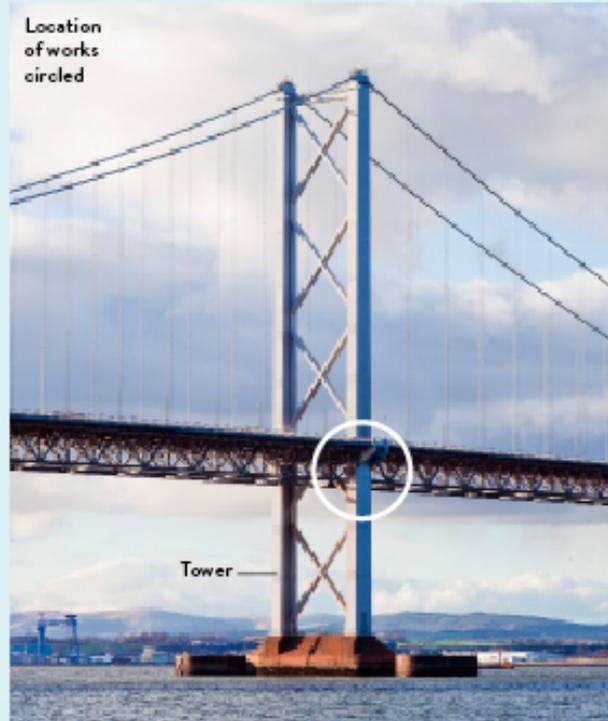
### 3 | PHASE THREE

A new bracket and bearing are installed to support the truss, eliminating the link.

The team is now working on the third and final phase of the work. Permanent brackets will be installed on each of the tower legs to support the truss from underneath, eliminating the truss end links entirely. This will also allow the team to remove the steel frame which had been installed above the deck during the phase two works and restore the bridge to its original category A listed appearance.

On each bracket sits a bearing. This bearing is now presenting a series of complicated challenges. For a start, under certain load conditions, it has to resist uplift, which in combination with providing a low friction sliding surface is not commonplace. The bearing surface must also be able to be replaced while still providing support to the truss.

It is a cellular steel structure wrapped in a steel skin and there are voids behind the locations of the two brackets. The external skin is too weak to take the loads exerted on the brackets, so the team has come up with a solution that involves filling the voids with reinforced concrete. Macalloy bars are then inserted through the tower structure into the concrete to take the loads from the new brackets.

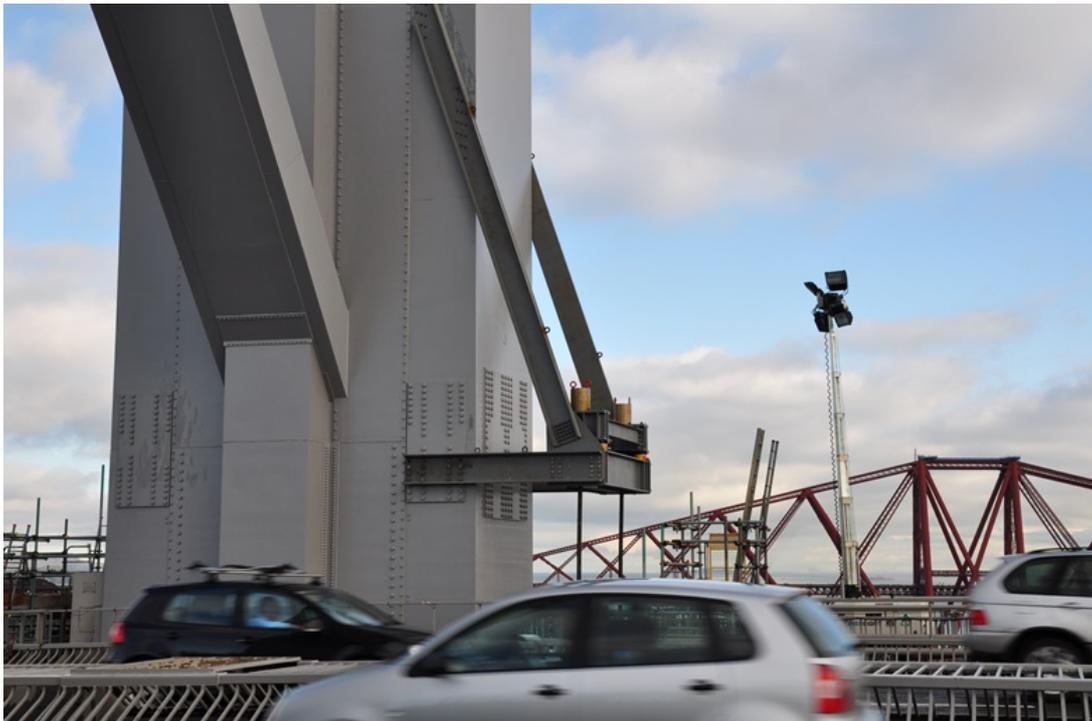
Forthbridge(6) phase two works complete

Phase two works involved attaching a temporary frame to the tower
